DOMESTIC HOT WATER -Follow operational sequence - (continue)

FAULT FINDING SOLUTION SECTIONS

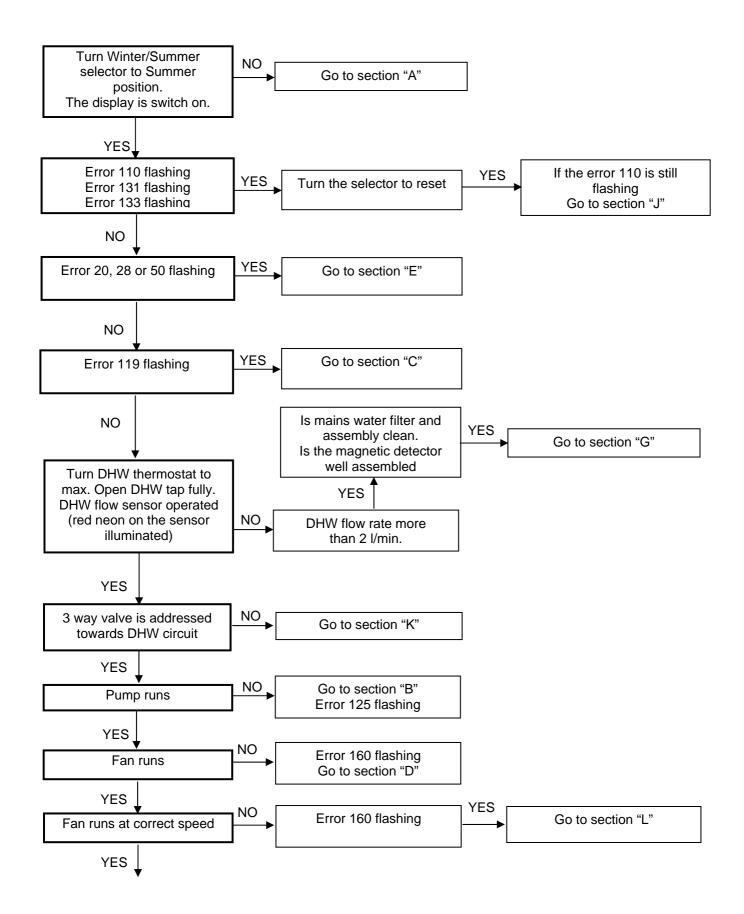
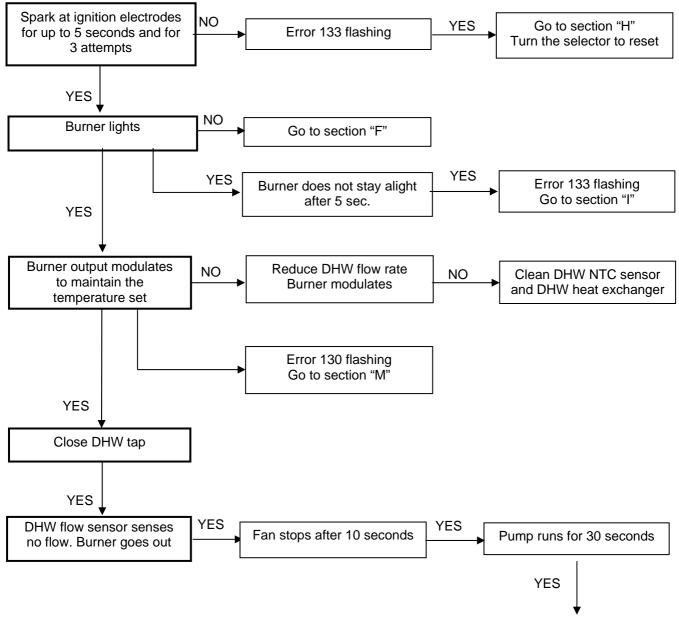
Operation sequence successful

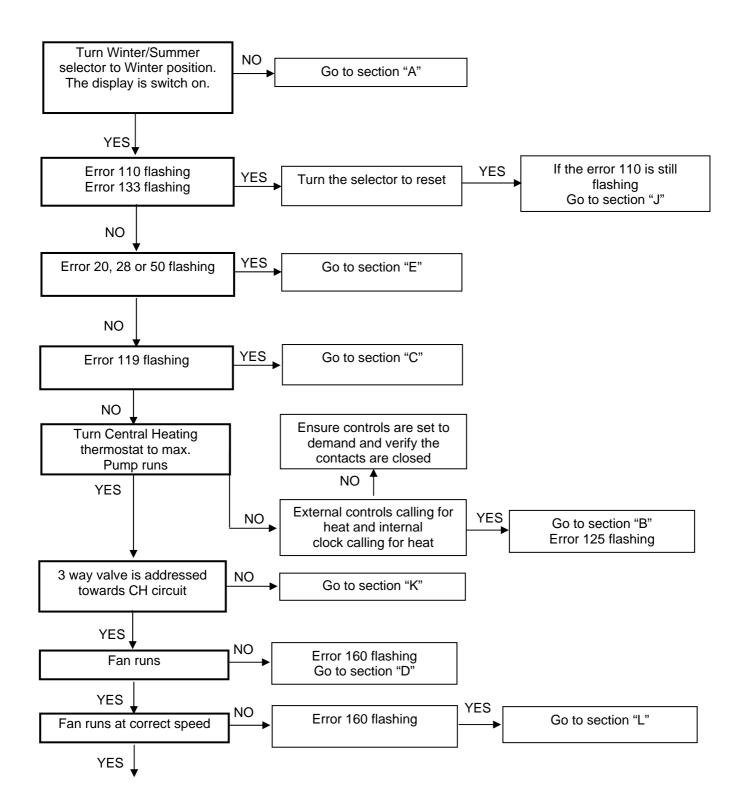
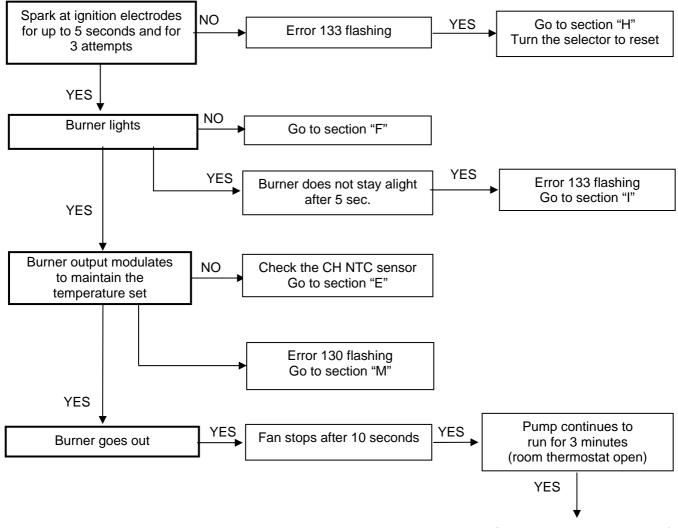
CENTRAL HEATING - Follow operational sequence – (continue)

Operation sequence successful

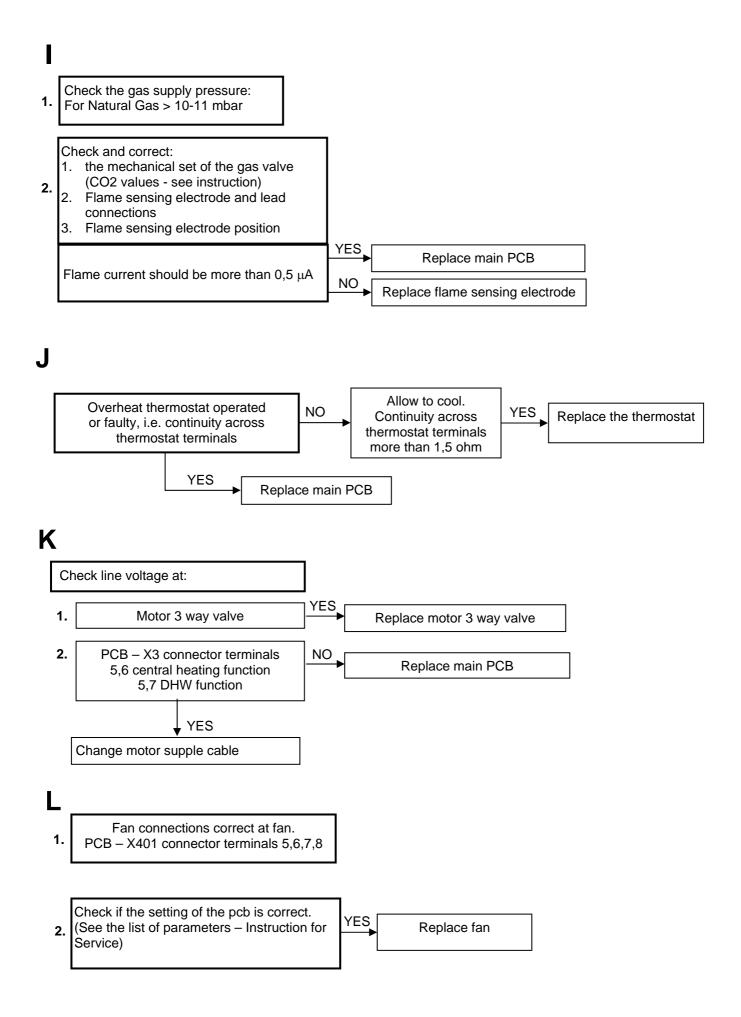
1.	Temperature sensors faulty. Cold resistance \cong 10 k Ω @ 25°C (CH sensor) 20 k Ω @ 25°C (FLUE sensor) (resistance reduces with increase in temp.)	NO Replace sensor
2.	If pump is running the exchanger could be obstructed	YES Replace exchanger
